GO Number	S/A Number	Page 1 of	Total Pages	Rev. Ltr/Chg. No. See Summary of Chg.	Number
97055	31170	145	145	NEW	EID-06141
Program Title Closure of ETEC (R21-RF)					
Document Title Hot Laboratory Decontamination and Dismantlement Final Report					
Document Type Engineering Information Document			Related Documents		
Original Issue Date 11/13/01		Release Date RELEASE 11/27/01 TV		Approvals Date	
Prepared By/Date D. W. Kneff D. M. Trippeda		Dept. 117 117	Mail/Addr T038 T038	R. D. Meyer	
IR&D Program? Yes <input type="checkbox"/> No <input checked="" type="checkbox"/> If Yes, Enter Authorization No.					
Distribution			Abstract

*	Name	Mail Addr.		<p>The former Rockwell International Hot Laboratory, located at Boeing Canoga Park's Santa Susana Field Laboratory in Ventura County, California, operated under Department of Energy funding from 1959 until 1987. It was used originally for the disassembly and examination of irradiated nuclear reactor fuel assemblies and test specimens, and later for the decladding of irradiated plutonium-bearing fuels from off-site reactors. Decontamination and decommissioning (D&D) of the facility was initiated in 1987, and facility dismantlement was complete

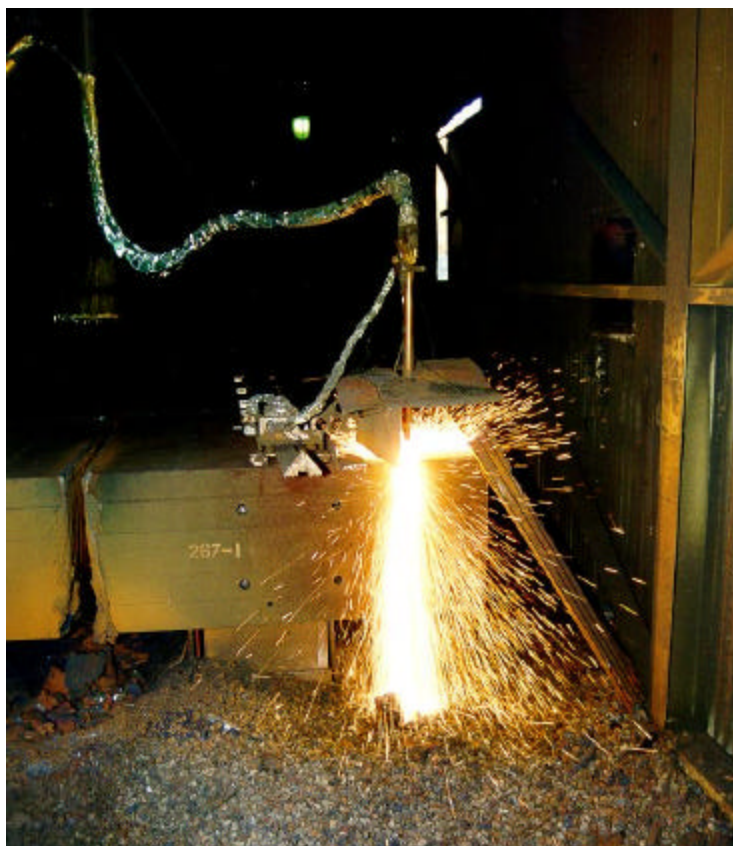
Figure 6-103. Size-Reduction of the Hot Cell Shield Doors Using a Powder Torch. [ETEC-10/26/98-395715]

The sections of the doors that could not be decontaminated were first cut from each door (Figure 6-103), and the door was then cut into quarters. No cuts were made across contaminated metal, to avoid the generation of contaminated smoke and dross. The torch-cut contaminated sections were surveyed and packaged for disposal as low-level radioactive waste. The remaining door segments were re-surveyed to assure complete decontamination and then released as non-radioactive scrap. Over 600 ft³ of previously contaminated material, weighing over 140 tons, was released as scrap metal for recycling. Figure 6-104 shows some of the size-reduced shield door sections that were released. The cutting and removal of the shield door sections was completed in October 1998 (the beginning of FY 1999).

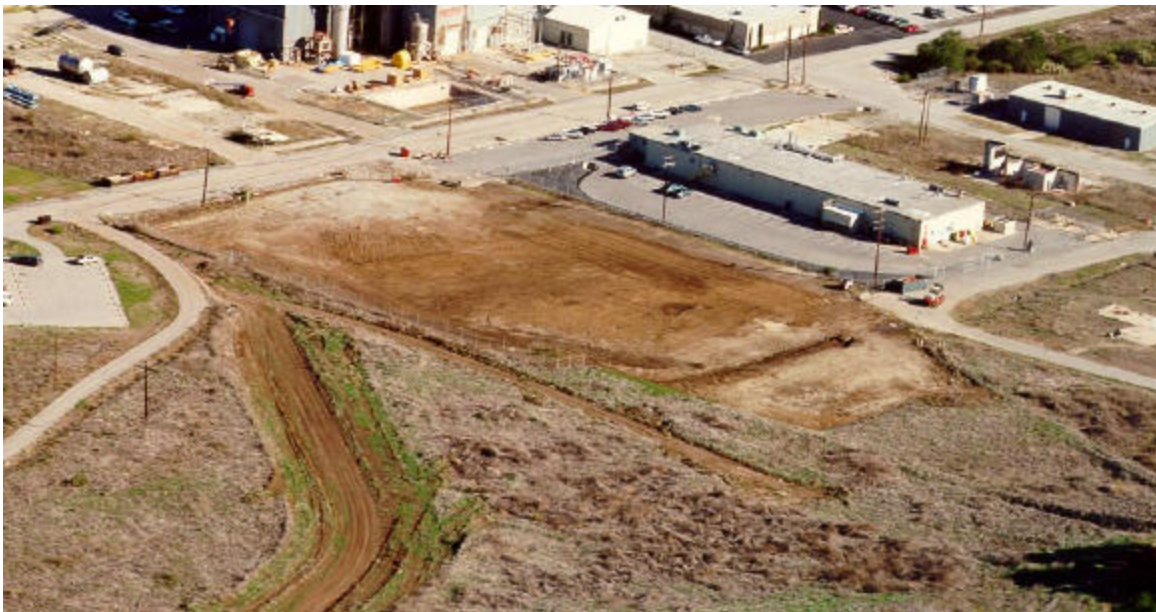
Figure 6-105. Graded Hot Laboratory Site at Completion of D&D Activities. [ETEC-12/7/98-395756]

ORISE provided verbal confirmation during the first quarter of FY 1999 that the Liquid Waste Facility and septic tank/leach pit area excavation was acceptable for unrestricted release. The excavation contractor placed a layer of sand at the base of the excavation as a marker, similar to that done in FY 1998 for the Hot Laboratory basement excavation, and backfilled and compacted the area with soil. The backfilling was completed on 11/5/98, and marked the completion of the Hot Laboratory decontamination and dismantlement project. Figure 6-105 shows the graded site in its final state, pending the final release surveys.
